**WASTE MANAGEMENT DIVISION
RCRA ENFORCEMENT OFFICE
RCRA COMPLIANCE EVALUATION INSPECTION REPORT**

Purpose: RCRA Compliance Evaluation Inspection

Facility: Freeport-McMoRan Sierrita, Inc.

Date of Inspection: August 11 and 12, 2009

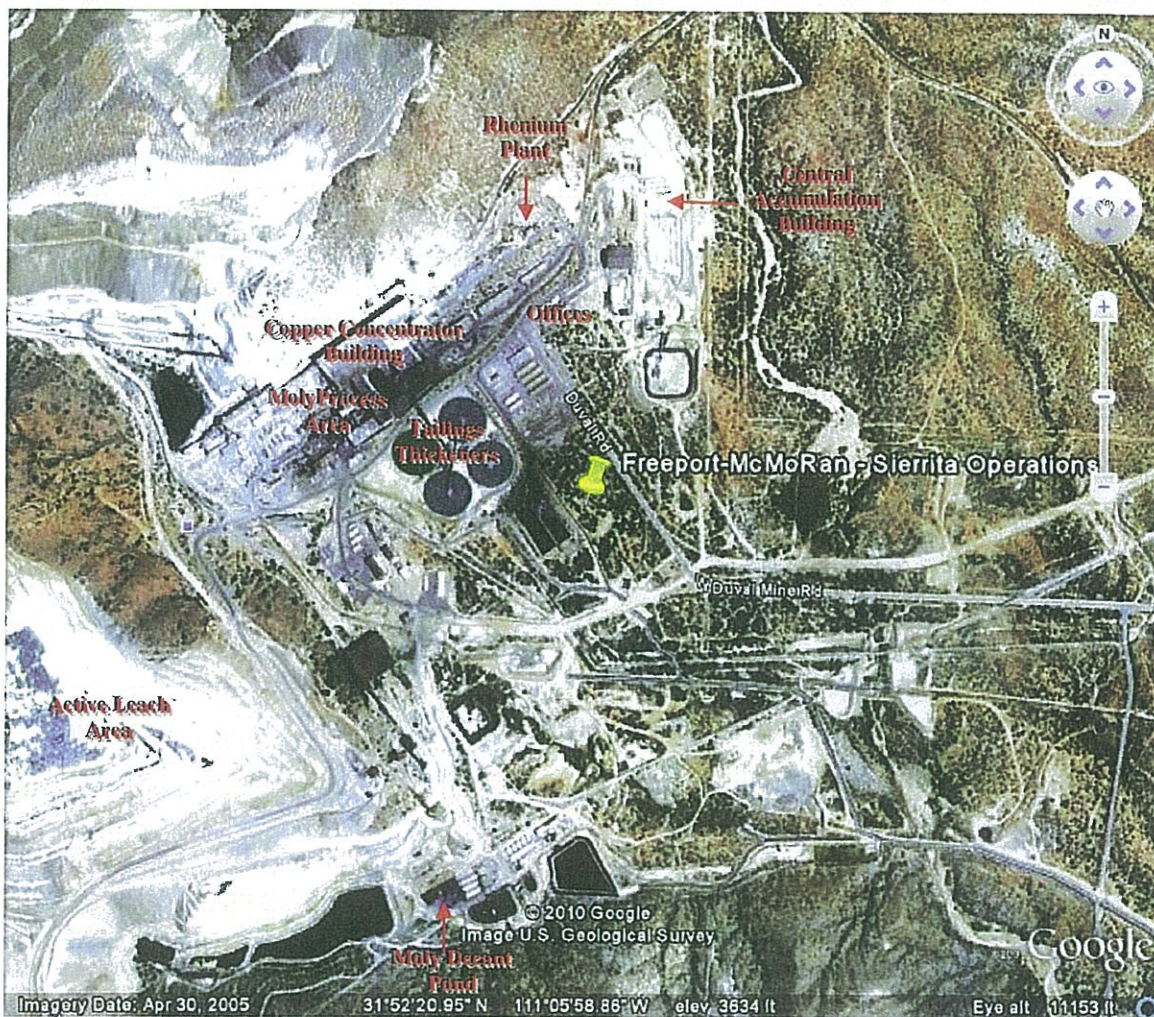
FM-Sierrita consists of three open pits, a concentrator, two molybdenum roasting plants, a ferromolybdenum chemical plant, a rhenium chemical plant, an oxide and low grade sulfide dump leaching operations, and a copper sulfate plant (Attachment 1 and aerial photograph below). Ore mined at the facility contains an average concentration of approximately 0.23 percent (0.23%) copper and 0.030% molybdenum.

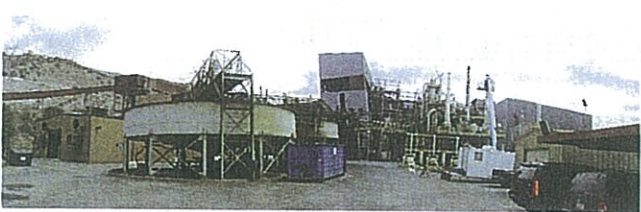
Photograph Number	Description	Photograph
1-1	Stitched panoramic photograph of Moly Processing Area.

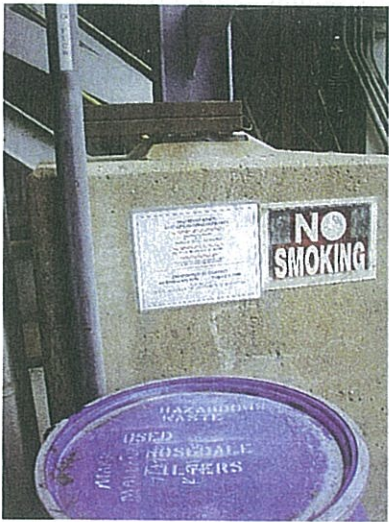
1-2	Satellite accumulation area located within Moly Processing Area. Signage states: 1. only one container per wastes stream, 2. maximum of 55-gallon of waste accumulated at point, and 3. satellite accumulation container must be kept closed except when adding or removing wastes from the container.

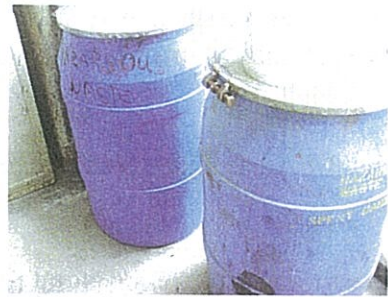
Photograph Number	Description	Photograph
1-3	Moly Processing Area. Satellite accumulation containers. Containers are marked and labeled, as required. No potential violations were observed at this hazardous waste satellite accumulation point.

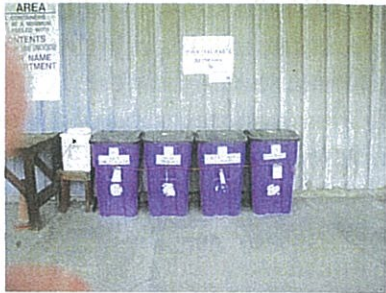
Photograph Number	Description	Photograph
4-1	Universal waste batteries are segregated by battery type (e.g., lead-acid) and placed in the appropriate marked container. No issues of concern were identified for the universal waste battery accumulation area.

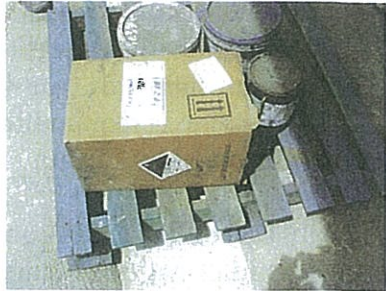
Photograph Number	Description	Photograph
4-3	Inside the Central Accumulation Building. One of the bays used to accumulate hazardous wastes. Note: concrete floor is in good condition with no significant cracks or staining.

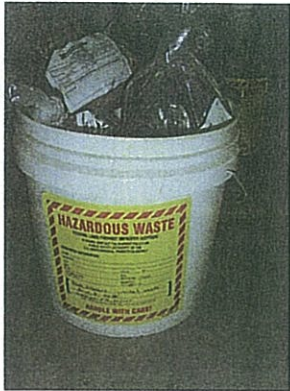
Photograph Number	Description	Photograph
4-6	Label of container pictured in Photograph 4-5 above. The lid to the container is missing (i.e., open container) and the accumulation start date is missing from the container label.

Finding: A five-gallon container of discarded D001 adhesives was labeled. However, the accumulation start date was missing. See Page 16, Photograph 4-6.

Response: Facility personnel corrected this potential violation on August 11, 2009.

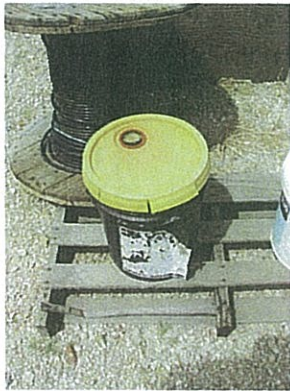
Photograph Number	Description	Photograph
5-1	Outside the fence, north side of the Salvage Storage Yard, a five-gallon pail of unknown material was observed. The container label has faded and peeled away apparently from being stored outside.

FM-Sierrita representatives stated that a contractor had left the containerized material at the site. Reportedly, contractor agreements with FM Sierrita require the contractor to be responsible for any hazardous materials brought onto the site by the contractor.

Finding: A five-gallon container of unknown material or waste was observed outside the north end of the Salvage Storage Yard. Page 16, Photograph 5-1.

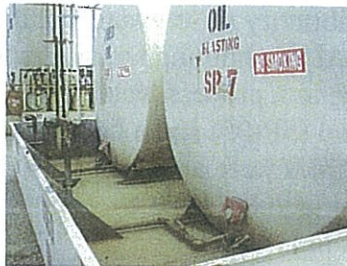
Photograph Number	Description	Photograph
8-2	Used oil accumulation tanks. Tanks are marked and labeled, as required. No significant liquid accumulation was observed within the secondary containment area. Note: Tanks are included in the facility's Spill Prevention, Control, and Countermeasures Plan (SPCC).

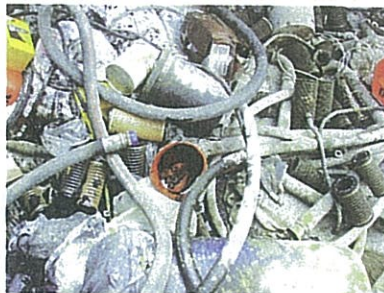
8-3	Contents of 20 to 40 cubic-yard roll-off container used to accumulate oily debris. Free liquid was observed in the orange bucket pictured in the middle of the photograph.

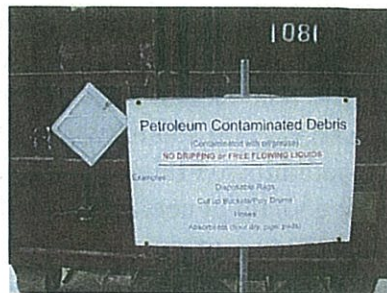
8-4	Signage posted outside oily debris accumulation container. Note that free liquids are not to be disposed in the roll-off container.

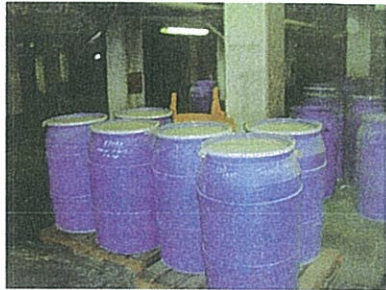
Photograph Number	Description	Photograph
9-1	Containerized lead flake located at the Twin Buttes Electrowinning Facility. Electrowinning operations are located on the floor above.

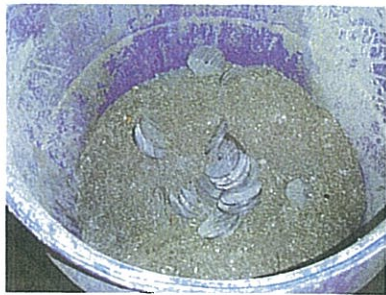
9-2	Contents of one of the lead flake containers.

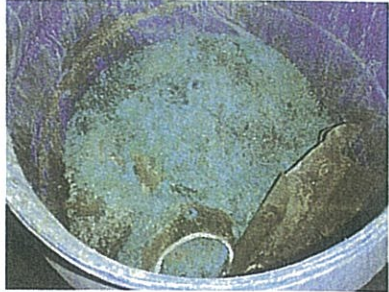
Photograph Number	Description	Photograph
9-3	Contents of one of the lead flake containers. Note: General solid waste is being accumulated in the container.

General trash was observed in several of the lead flake accumulation containers. FM Sierrita should initiate procedures to ensure that only lead flake that can be reclaimed at the Doe Run facility is accumulated in the containers.

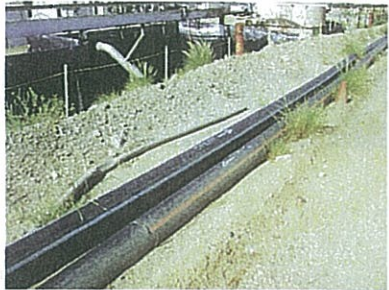
9-4	Pipe lines which carry pregnant solution from the SX Plant to the electrowinning facility and return "spent" solution back to the SX Plant.

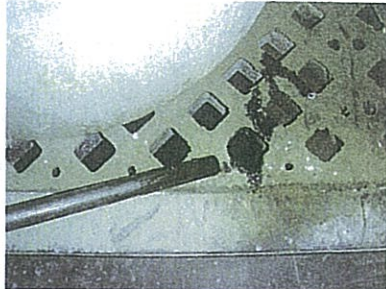
Photograph Number	Description	Photograph
10-2	The secondary containment pallets pictured in Photograph 10-1 above contained approximately 4 inches accumulated oil and water. Any accumulated liquids in secondary containment pallets should be removed as soon as practical.

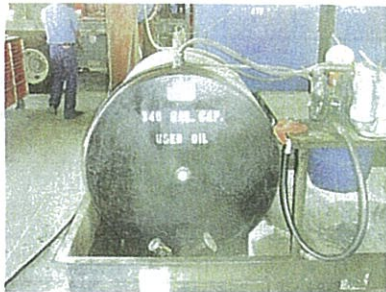
10-3	The approximately 350-gallon tank pictured is used to accumulate used oil. The tank is marked and labeled, as required. Secondary containment did not contain any appreciable quantities of accumulated liquids.

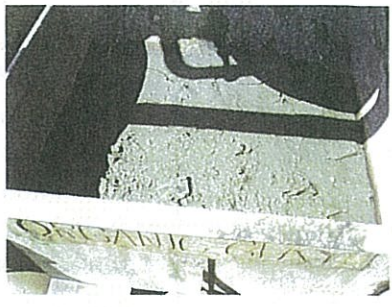
Photograph Number	Description	Photograph
11-2	Contents of "crud" bin pictured in Photograph 11-1 above.

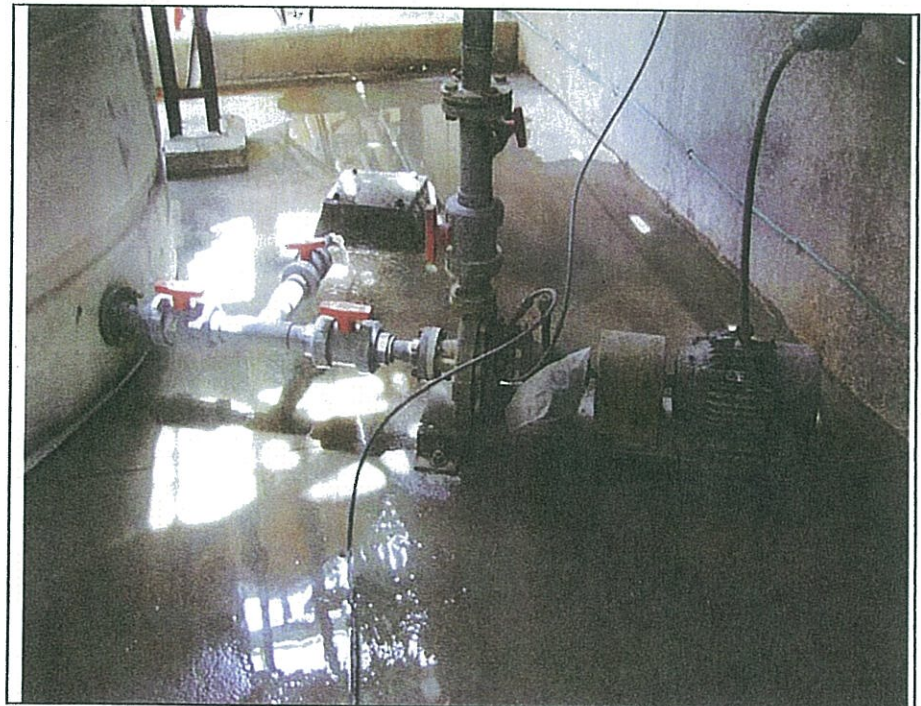
COMMENTS: SP2 – Rhenium SX Raffinate. Sample collected from bleed stream on feed line to pump.

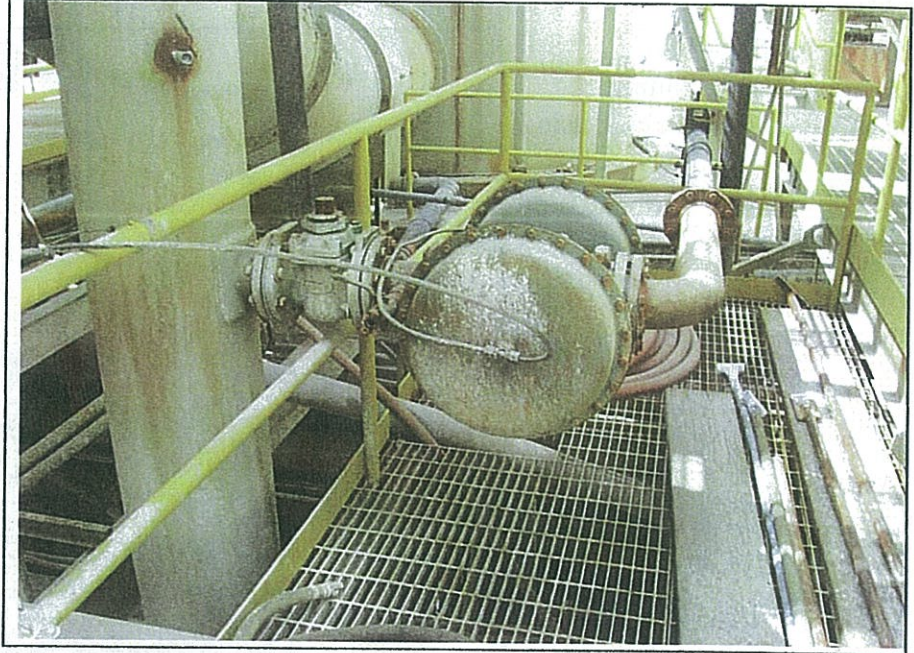
COMMENTS: SP3 – Lime Scrubber Bleed. Sample collected from one-inch quick-connect bleed line shown between manual block valve and actuated valve in photograph. A rubber hose was connected to bleed line and run to a suitable drainage location.

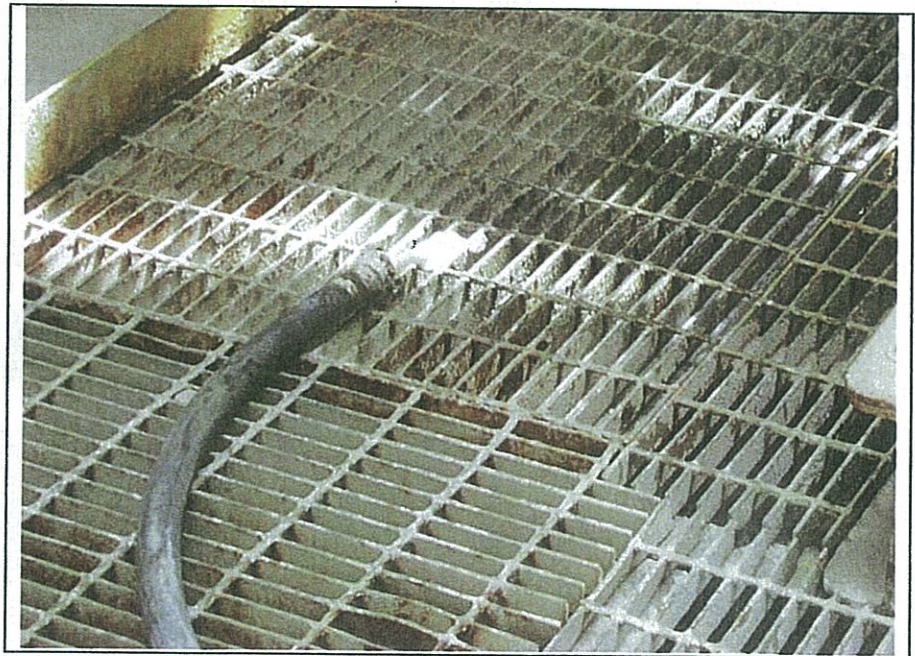
COMMENTS: SP3 – Lime Scrubber Bleed. Sample was collected from rubber hose attached to bleed line.

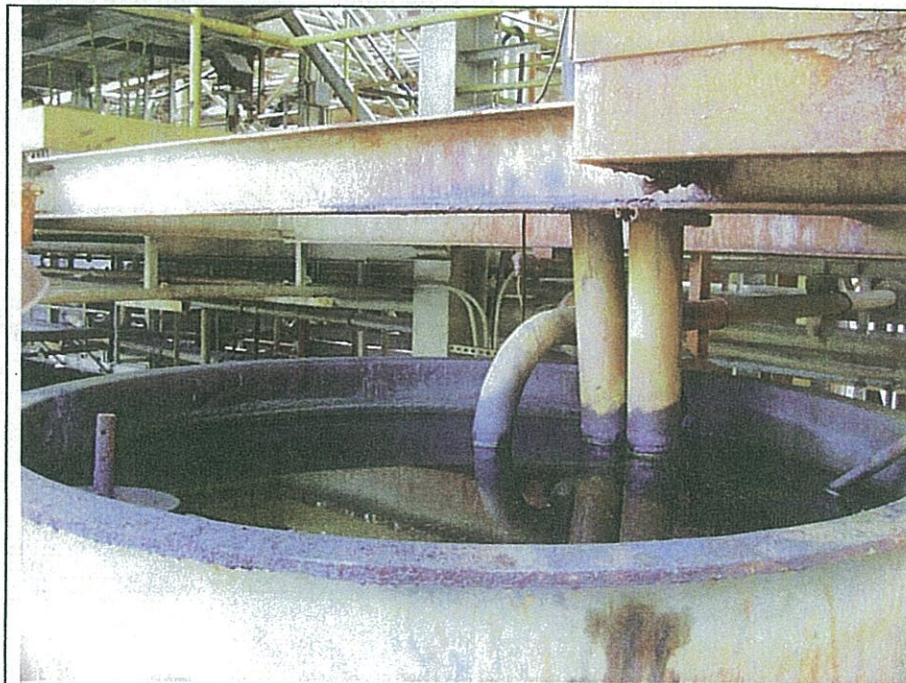
COMMENTS: SP4 – Ferric Solution Leach Bleed. Sample collected from top of open tank using a dipper cup.

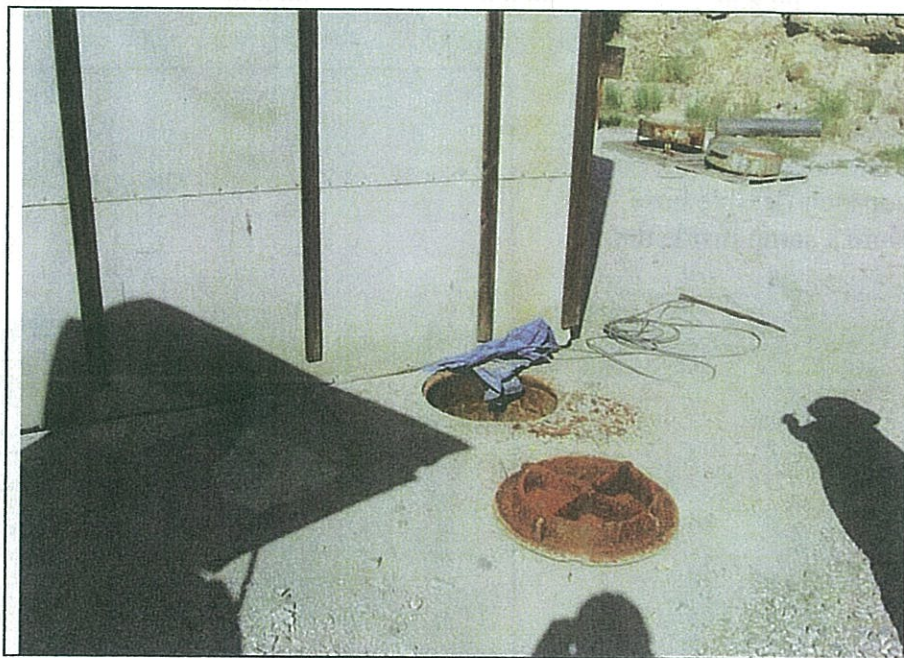
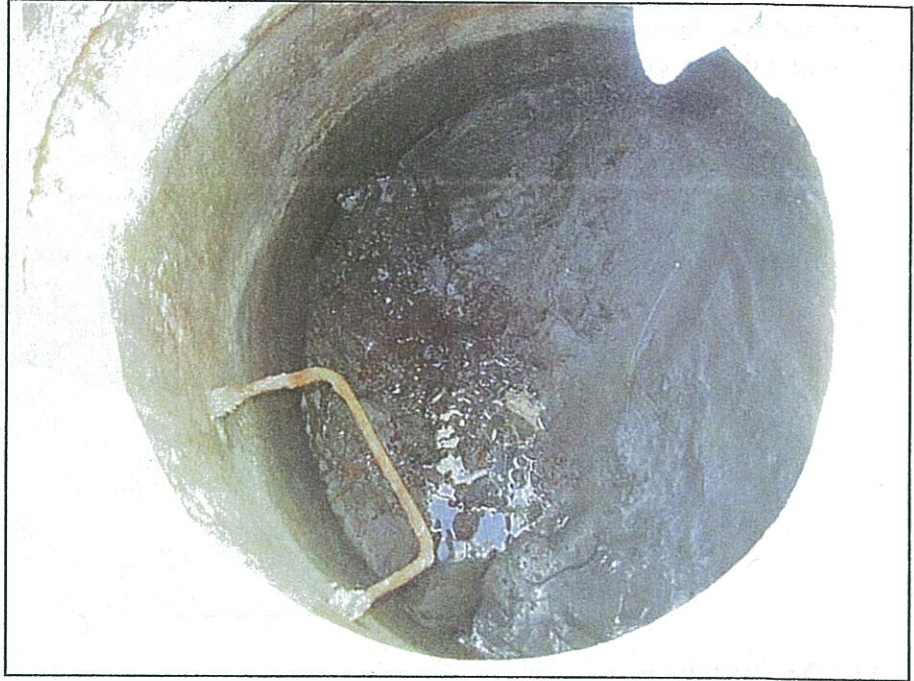
COMMENTS: SP6 – Analytical Lab Discharge Neutralization Sump. Sediment sample collected from bottom of piping in manway.

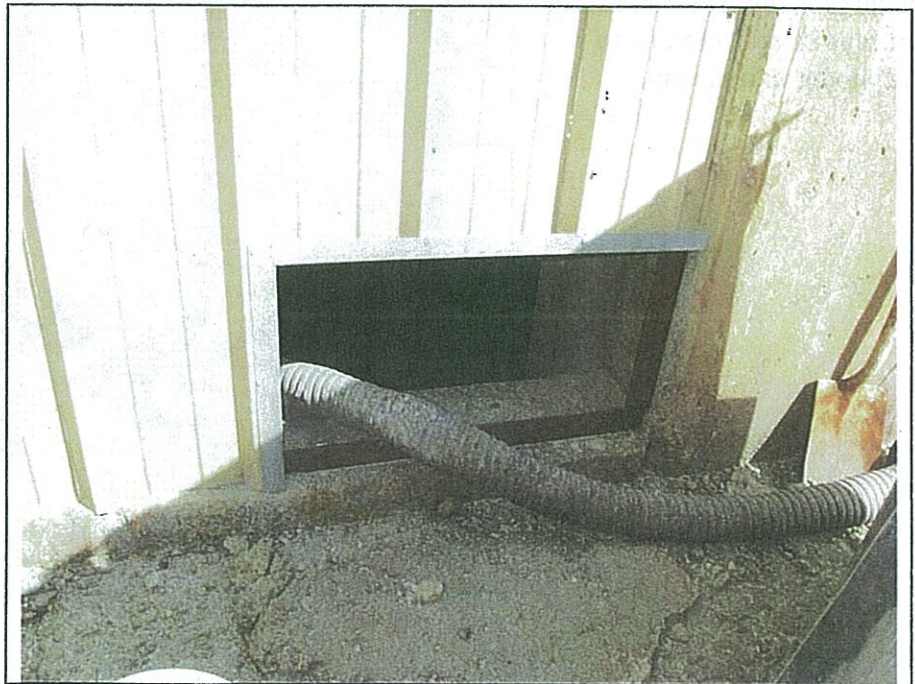
COMMENTS: SP7 - Lab
Neutralization Tank Discharge.
Sample collected in a bucket from
end of four-inch flexible hose
draining into a sump inside the
building.

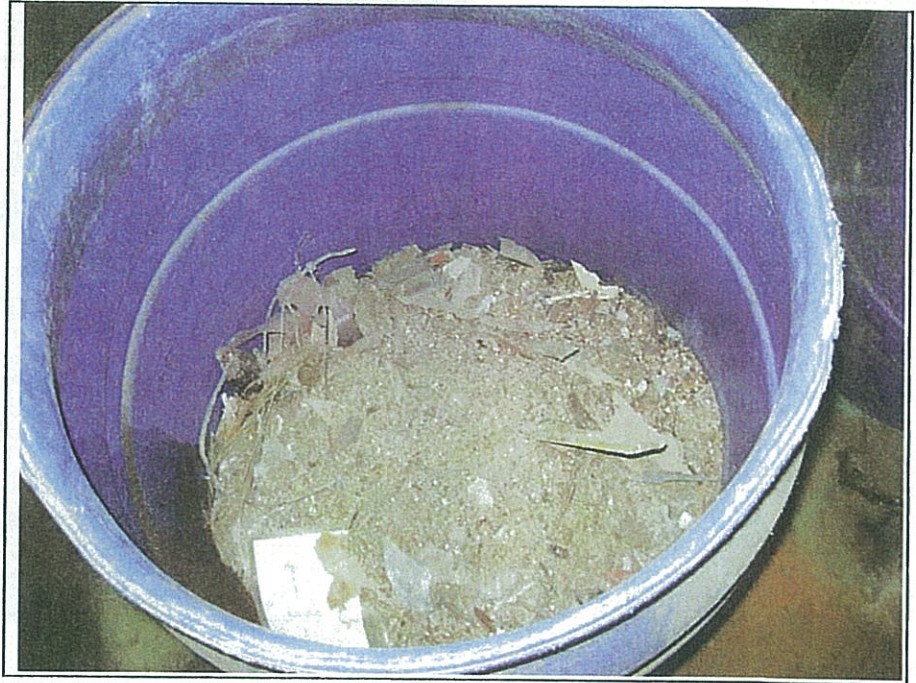
COMMENTS: SP8 – EW Lead
Flakes. Solid sample collected from
top of blue drum center and forefront
in the photograph. Drums are located
in a warehouse area at the Twin
Buttes Operations site.

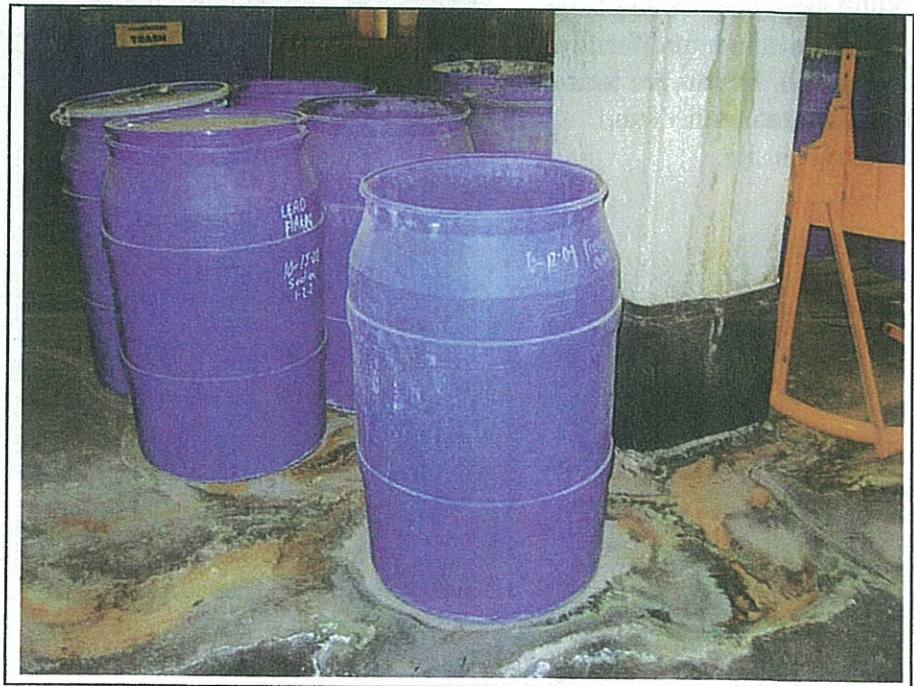
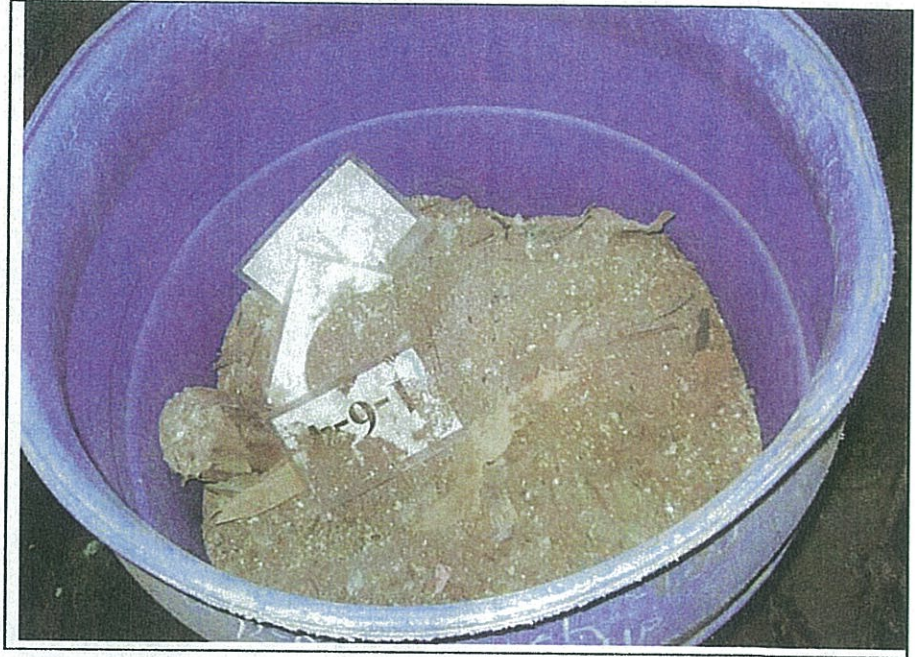
COMMENTS: SP9 – EW Lead Flakes. Solid sample collected from top of blue drum center and forefront in the photograph. Drums are located in a warehouse area at the Twin Buttes Operations site.

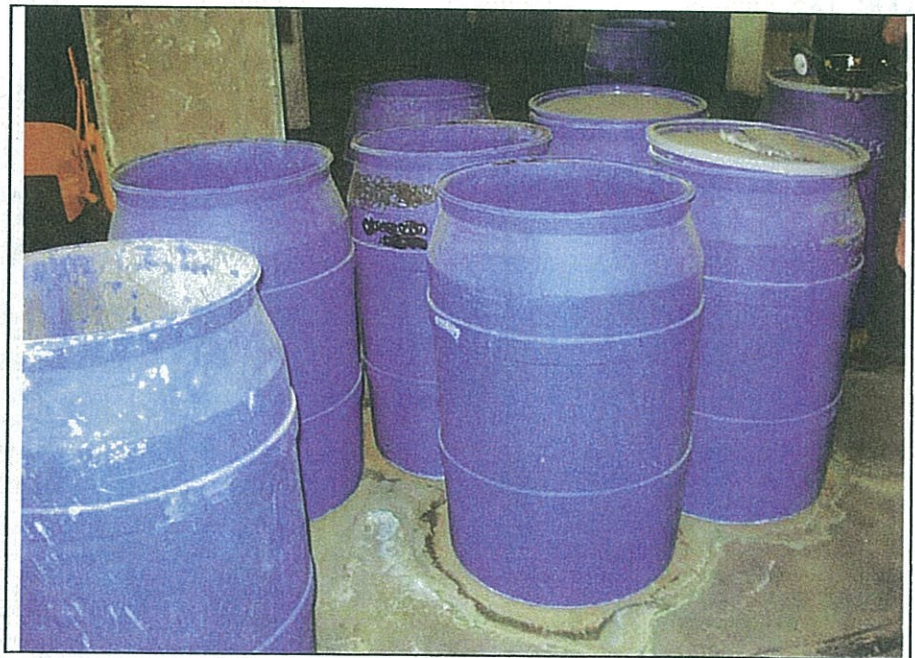
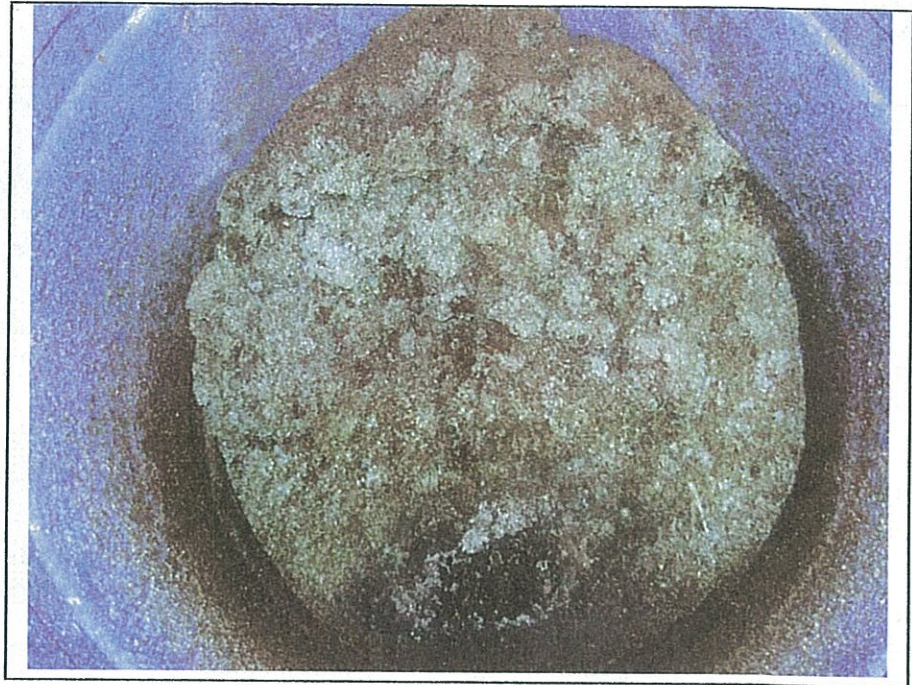
COMMENTS: SP10 – EW Lead
Flakes. Solid sample collected from
top of blue drum centered in the
photograph. Drums are located in a
warehouse area at the Twin Buttes
Operations site.

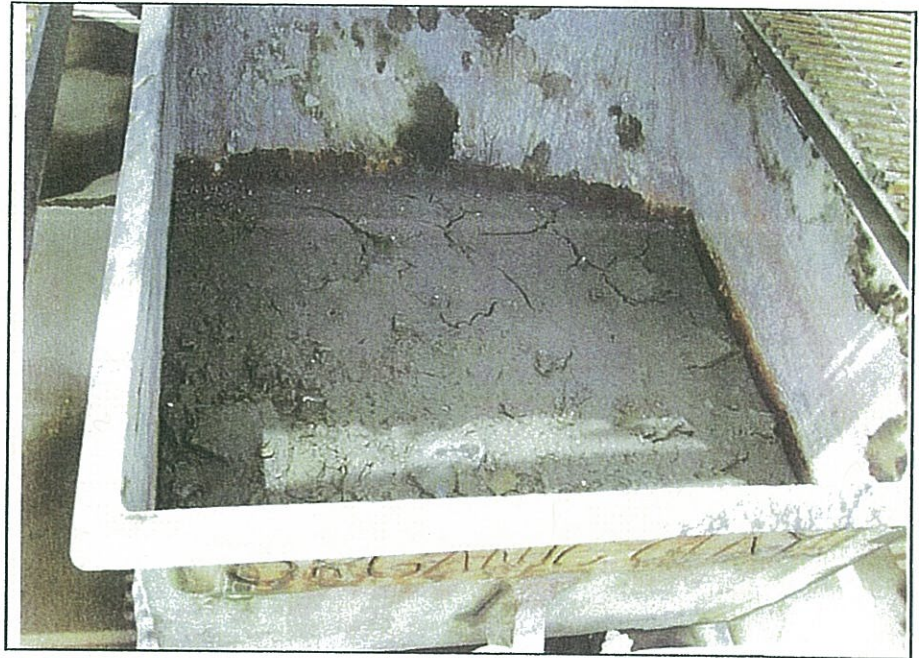
COMMENTS: SP11 – SX Crud.
Solid sample collected from crud
collection bin.

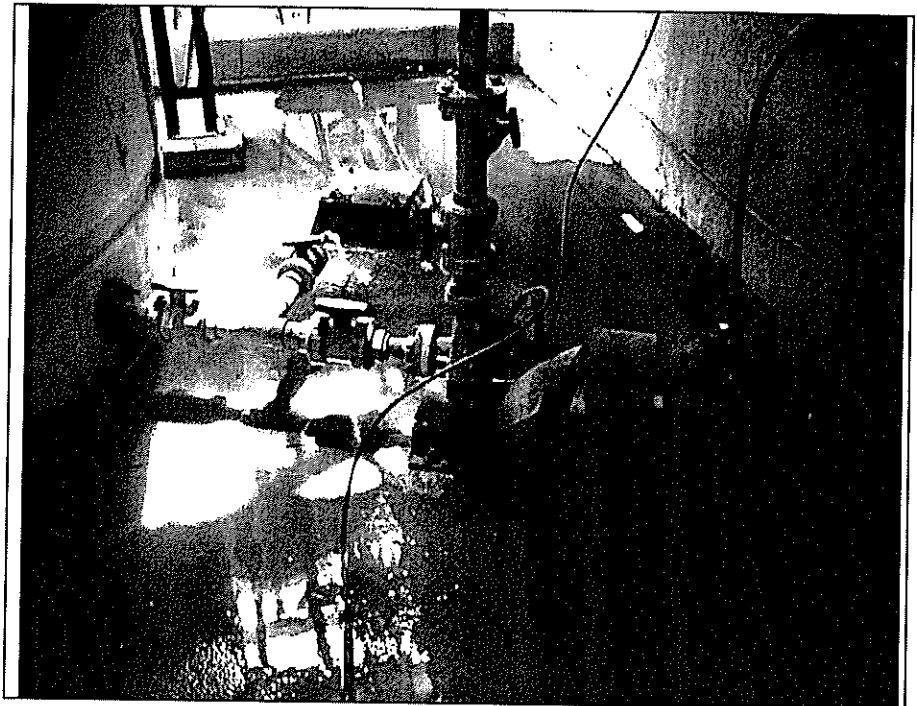
COMMENTS: SP2 – Rhenium SX Raffinate. Sample collected from bleed stream on feed line to pump.

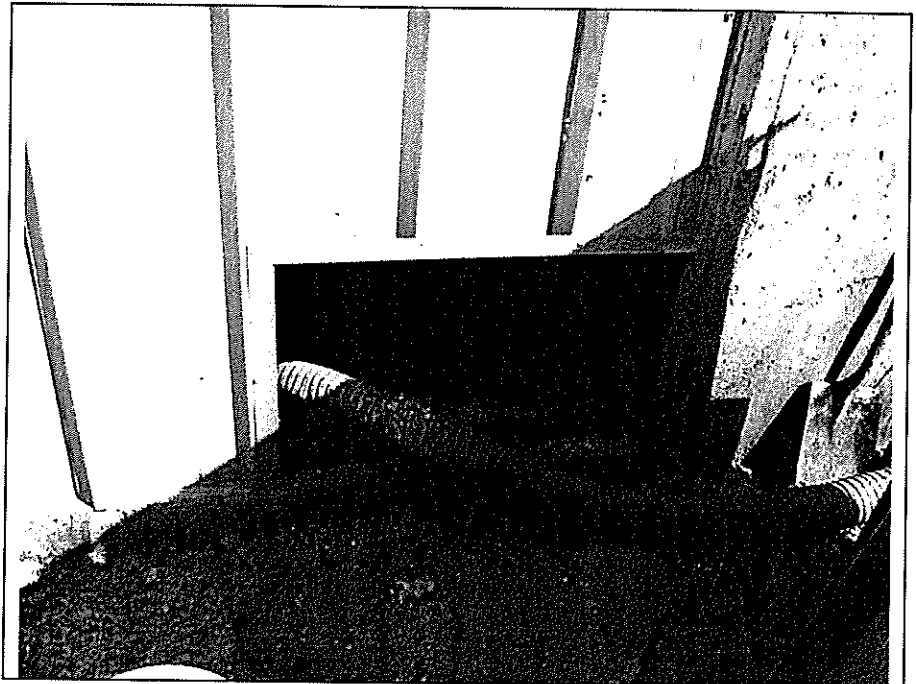
PHOTO #: 10

COMMENTS: SP7 - Lab
Neutralization Tank Discharge.
Sample collected in a bucket from
end of four-inch flexible hose
draining into a sump inside the
building.

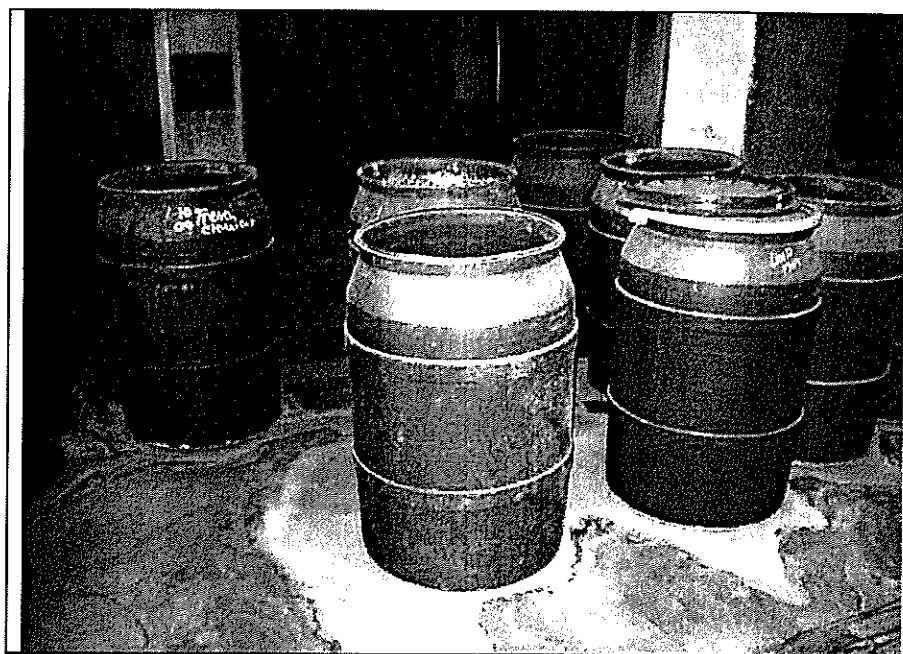
PHOTO #: 12

COMMENTS: SP8 – EW Lead Flakes. Solid sample collected from top of blue drum center and forefront in the photograph. Drums are located in a warehouse area at the Twin Buttes Operations site.

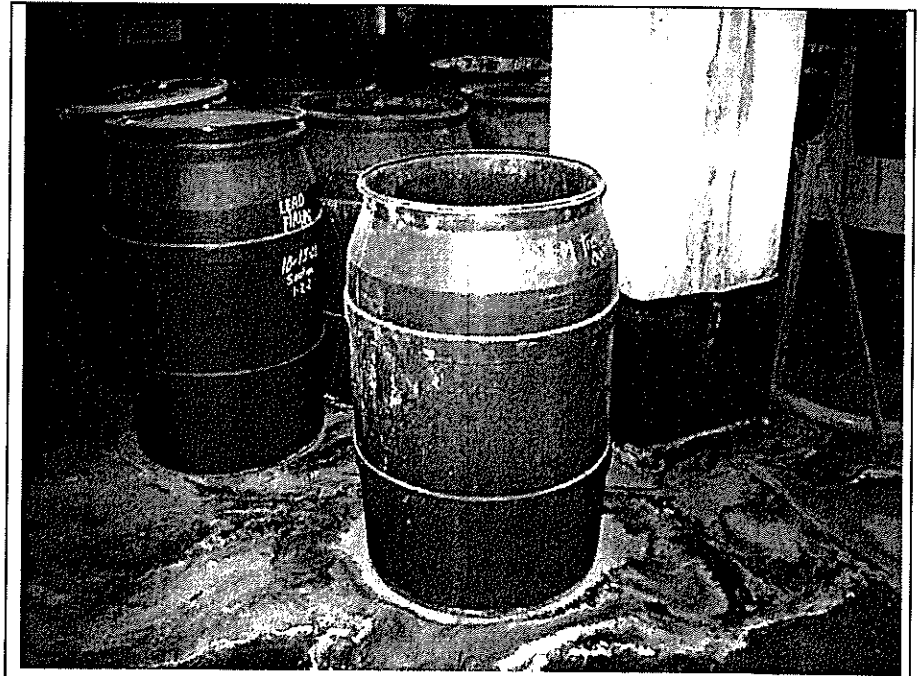
PHOTO #: 14

COMMENTS: SP9 – EW Lead
Flakes. Solid sample collected from
top of blue drum center and forefront
in the photograph. Drums are located
in a warehouse area at the Twin
Buttes Operations site.

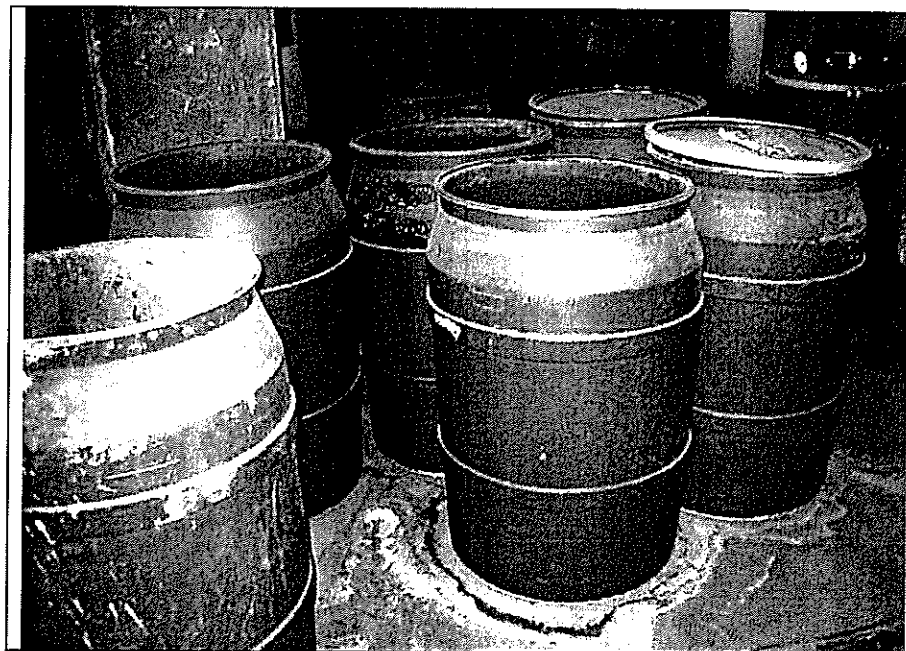
PHOTO #: 16

COMMENTS: SP10 – EW Lead Flakes. Solid sample collected from top of blue drum centered in the photograph. Drums are located in a warehouse area at the Twin Buttes Operations site.

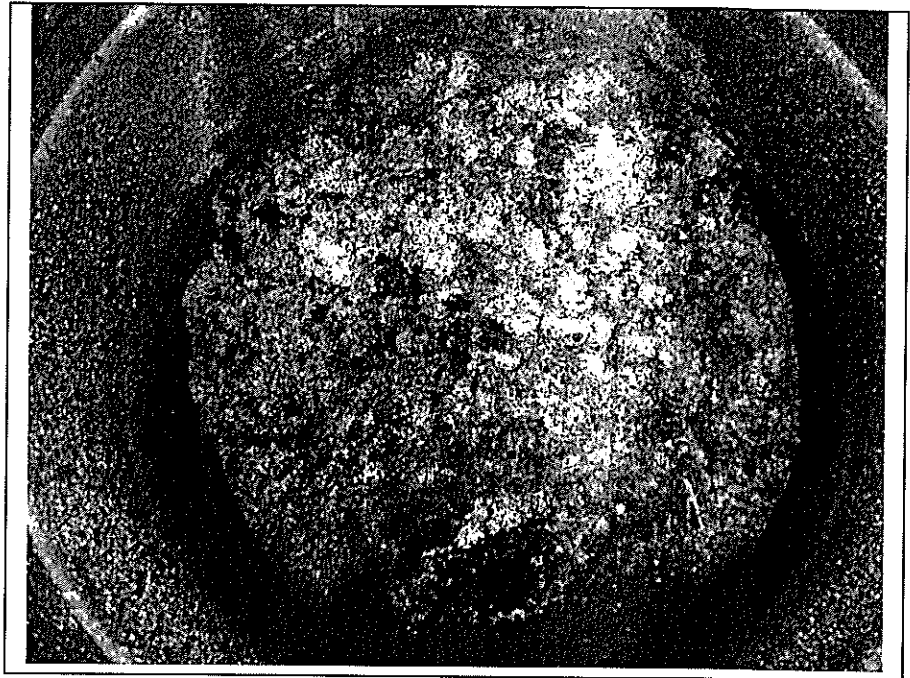
PHOTO #: 17

COMMENTS: SP10 – EW Lead
Flakes. Solid sample collected from
top of blue drum.

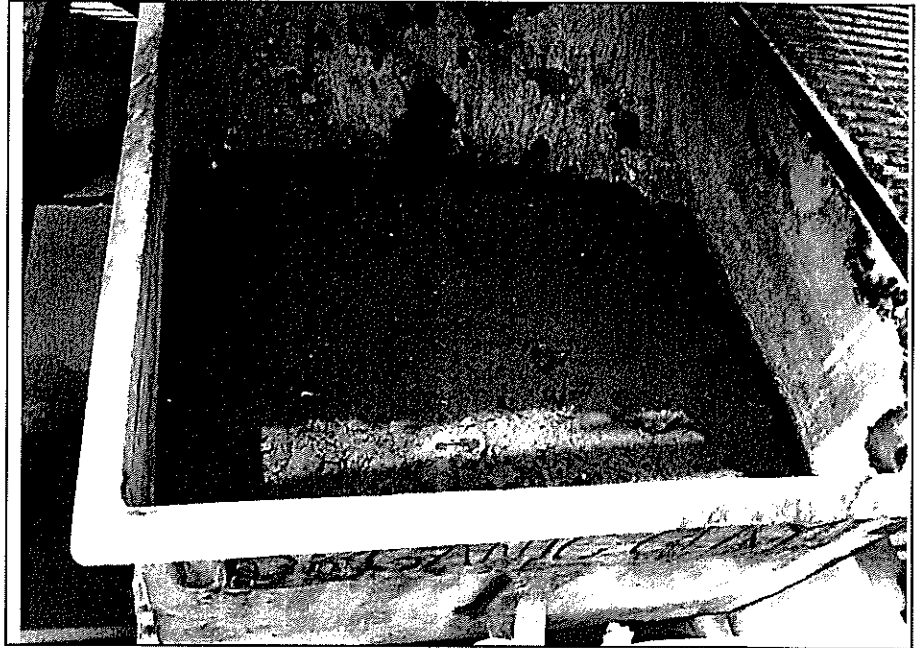
PHOTO #: 19

COMMENTS: SP11 – SX Crud.
Solid sample collected from crud
collection bin.
